Hydraulics Section	Medium Complexity Stream Summary	Date: 1/19/23
	Project Name: PHD Unnamed Tributary to Kinman Creek	WDFW ID Number: 991242
	Project Office: Jacobs Engineering Group, Inc. Bellevue WA	County: Kitsap
	Stream Name: Unnamed Tributary to Kinman Creek	State Route/MP: SR 3 MP 57.23

Brief Project Summary

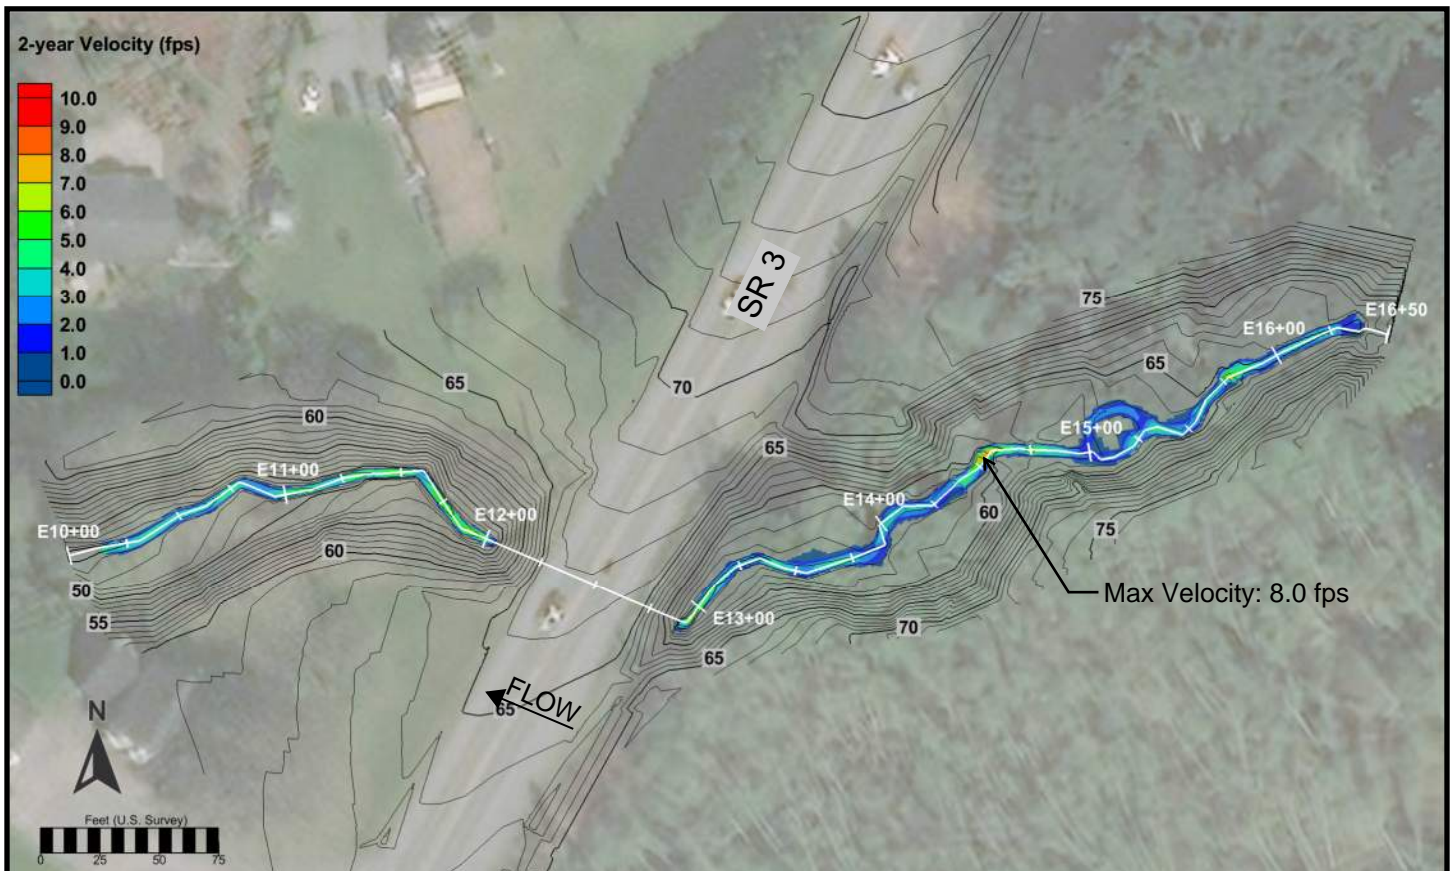
Existing Condition—Q2 Velocity (fps)
